NRL/MR/6110--99-8399

FIELD TOUR OF UXO ACTIVITIES ON THE FORMER NAF ADAK

23 June 1999

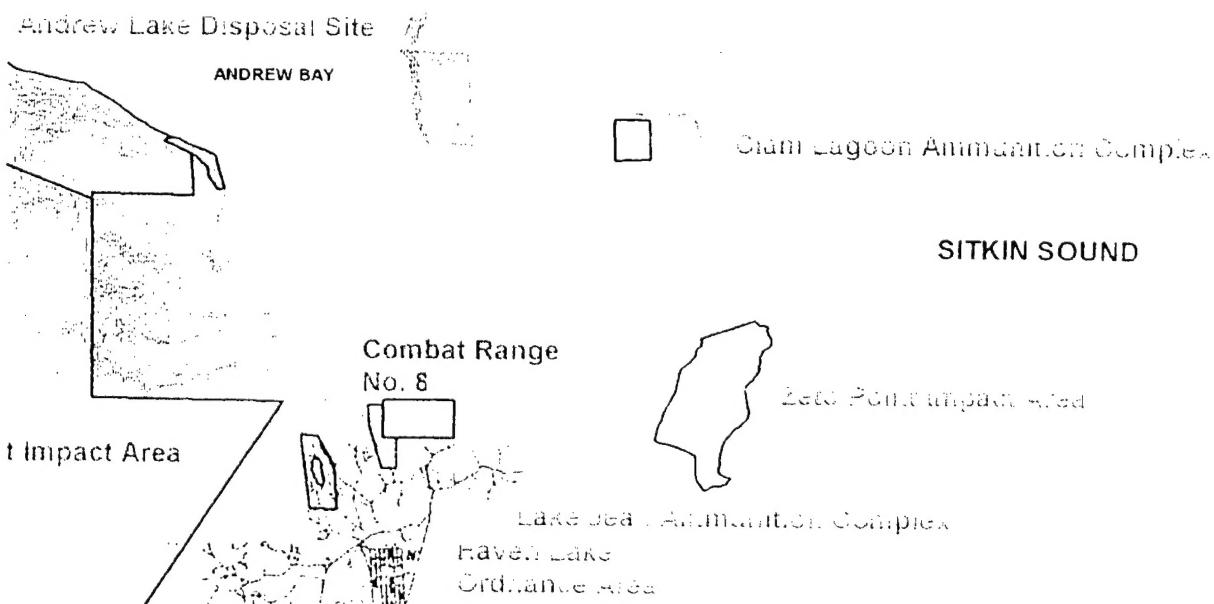
Figure 3. Expanded topographic map of Adak Island showing several of the areas of concern near Lake Andrew.

We skirted a section of the south and western edges of this site, walking about 0.4 miles overland. See Figure 3. The grass mat is 0.5-1.5 feet thick, the surface is varied, the highly

weathered areas have extensive gullies and relatively steep ($>15^{\circ}$) slopes. The flatter areas are rolling with shallow slopes and small depressions. We observed extensive debris, including timbers, metal scrap and assorted abandoned junk randomly scattered on the surface. We estimate that *MTADS* could traverse 40-50% of the area, although it would be highly susceptible to bottoming out or becoming stuck on high center from dropping a wheel into hidden depressions. We observed no ordnance-related items at this site.

This area is contiguous with and overlaps the western edge of Combat Range No 8. We walked the length of this site, briefly skirting around the edge of the Lake Andrew shoreline. The terrain is much like the area described above. Areas along the shoreline and edge of the lake could be surveyed by *MTADS* up to the point that steeply rising slopes limit access.

drove and walked up the East-West trending glacial valley to the area of the detonation and burn pits. The area, slowly rising from the lake shore, is relatively flat wetlands. The valley, itself, which stretches across the southern edge of the area labeled Parcel 4 in Figure 3, gently rises to above the detonation and burn pits. On the northern side of the valley there are protective works associated with a grenade training range. Impact areas were pointed out for ordnance described to be 40, 60, 81 and 105 mm. In the center of the valley is the obvious OB/OD area. This area, as shown in Figure 4, is heavily cratered, much of it is obviously saturated with frag and OE scrap. Some intact fuzes and components are visible, scattered about the area. Ordnance surveys in the immediate OB/OD area would be impractical, as the area is saturated with scrap.
